NIOSH
Fire Fighter Fatality Investigation
and Prevention Program

A summary of a NIOSH fire fighter fatality investigation

November 03, 2009

Career Fire Fighter Dies When Backed Over While Spotting an Apparatus—New Jersey

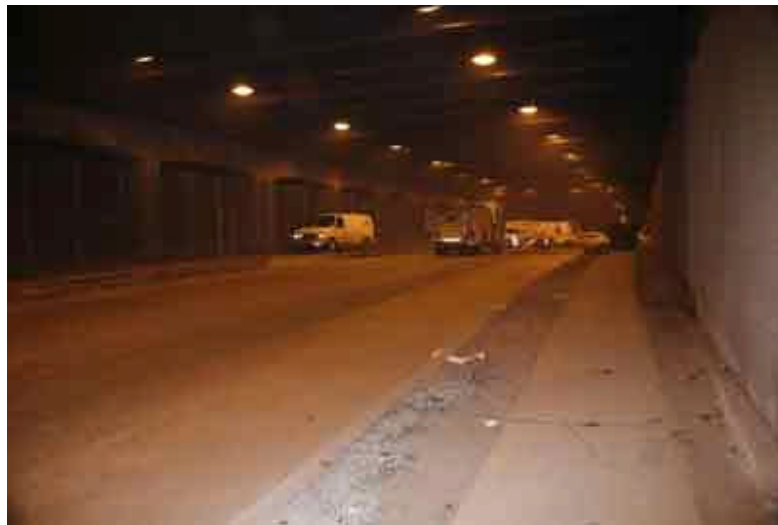
*Incident scene
(Photo courtesy of police department.)*

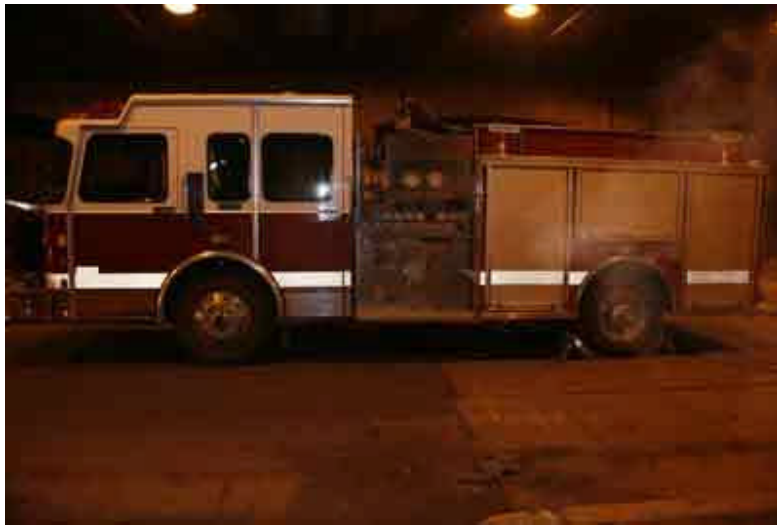
The victim was the acting officer on the engine along with the chauffeur and fire fighter. The apparatus involved in the incident was a 1996 enclosed cab engine with an automatic transmission, diesel engine, and an air brake system ([see Photo 1](#)). The apparatus' gross vehicle weight rating (GVWR) was 32,360 lbs. The engine had two axles with six wheels (two in the front and four in the rear). The engine measured 28 ft (length) x 8 ft 7 in (width) x 9 ft 5 in (height). The apparatus was also equipped with an automatic reverse braking system³ mounted to the rear step of the apparatus ([see Photo 2](#)).

Photo 1. Apparatus involved in the backing incident.
(Photo courtesy of police department.)

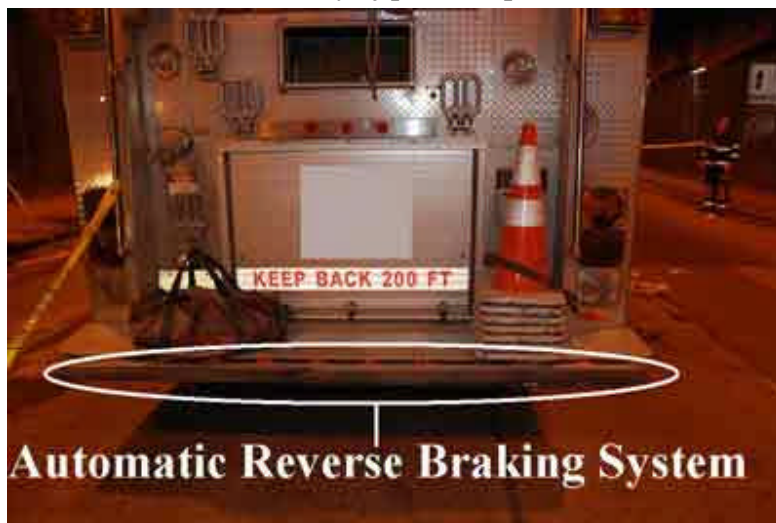
Photo 2. This reverse braking system is attached to the rear bumper of the apparatus and is designed to actuate the rear brakes when pressure is applied to the rubber

sensor.

This automatic reverse braking system was developed in the early 1980s, introduced in the United Kingdom in 1983, and then became available in the United States in 1986. This reverse braking system was an optional safety feature that was installed on the apparatus prior to the fire department taking possession in 1996. The system aids driver/operators while backing an apparatus by locking the rear brakes when the system comes in contact with an object. *Note: The manufacturer's manual notes that this system does not exempt the driver/operator from using conventional backing aids such as side and rear mirrors or spotters.*³ The rubber sensor is mounted six inches beyond the vehicle's rear end to provide an area where vehicle damage could be reduced due to the short distance traveled after automatic brake application. The sensor has an air chamber which is sealed at either end. The air chamber detects or senses a compression of the wall of the chamber, as little as 0.05 psi, causing the pressure inside to increase and then transmit down to a control/switch unit which triggers the brakes to actuate. The system is designed to operate when the apparatus is in reverse gear and backing at a slow rate of speed. The instruction manual recommends a function test be done after initial installation and at least once a week thereafter. For the involved apparatus, the last documented function test was performed in March 2008; at that time, the system was working properly.

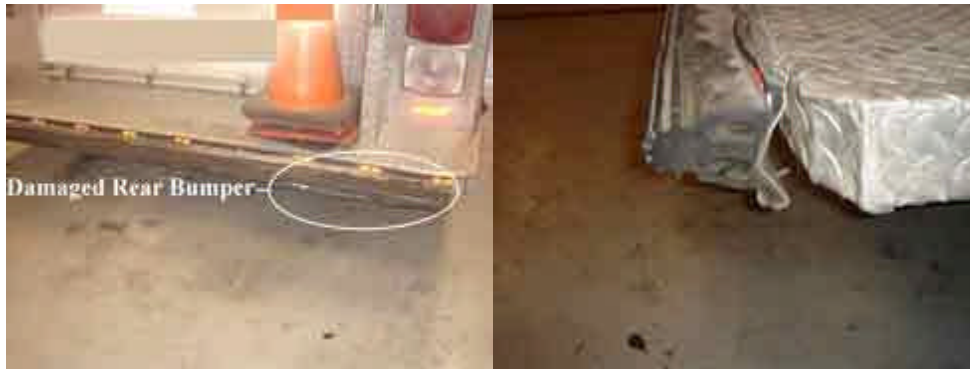
After the incident, the apparatus and scene were processed by local police before the apparatus was escorted by state police to the fire department's headquarters. The apparatus was secured there until state police could perform a vehicle inspection. The state police performed a standard commercial vehicle crash inspection in the presence of a fire department mechanic and investigators from the New Jersey Division of Fire Safety. Items inspected included the air brake system, brakes, steering, suspension, tires, lighting, and low air pressure indicators. The inspection was completed within three days of the incident and the apparatus was found to have no mechanical violations. The state police inspection did not include an inspection of the automatic reverse braking system because it was an optional device and their investigators were not certified to test it. However, when pressure was applied to the rubber sensor while backing, the system failed to actuate the brakes. It could not be determined whether the backing system was functional at the time of the incident, but there was damage to the bumper and rubber sensor that could not be attributed to the fatal incident ([see Photos 3 and 4](#)).

Photos 3 and 4. Pictures show damage to rear bumper and rubber sensor.
(Photo courtesy of PEOSH.)

From these findings, the New Jersey Division of Fire Safety recommended that repairs be made before placing the apparatus back in service. The automatic reverse braking system control unit was replaced following the inspection, and then placed back in service. The fire department also inspected eight other apparatus that had the same reverse braking system installed. Three of these apparatus had damaged or insufficient operating parts within the system that affected proper operation. These three systems were also repaired.
